# BEFORE AND EARLY ST MARY'S COLLEGE – BEFORE AD 1520 AND POSSIBLY BEFORE 1435

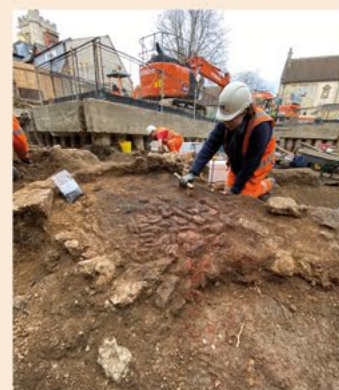
Left: Building 2 hearth or oven; Right: Building 3 Kitchen hearth with upturned broken ceramic cooking pot

**Building 2** – this stone building did not have a basement and the ground floor was surfaced in gravel with a circular hearth or oven set into the north-west corner. This building may have been a kitchen, or a bakehouse – but equally a brewhouse or an artisans workshop for cloth dying or metal-working. Only further analysis will tell. The north wall foundation had a series of 3 relieving arches in it – this helped to stabilise construction on soft ground. It is on the same alignment as a boundary wall that runs parallel with Shoe Lane.

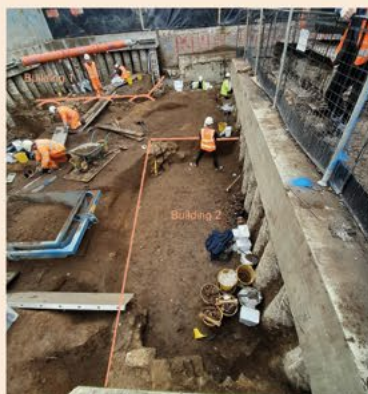
Left: Building 1 basement under excavation; Top right: The stone-lined cess pit with putlog holes; Bottom right: Building 2 relieving arches in north wall

**Building 1** – This is a stone-walled basement – demolished and heavily robbed. This may have been built in the 13th or 14th century and there would have had a first-floor room above the basement. Building 1 may have joined onto Building 3 (on the other side of the excavation).
